FMC OU Soil Remedial Action

Performance Standards Verification Plan For RA-J and Cleaning Stormwater Piping In RA-A

RA-A Stormwater Pipe Cleaning Report

July 2015

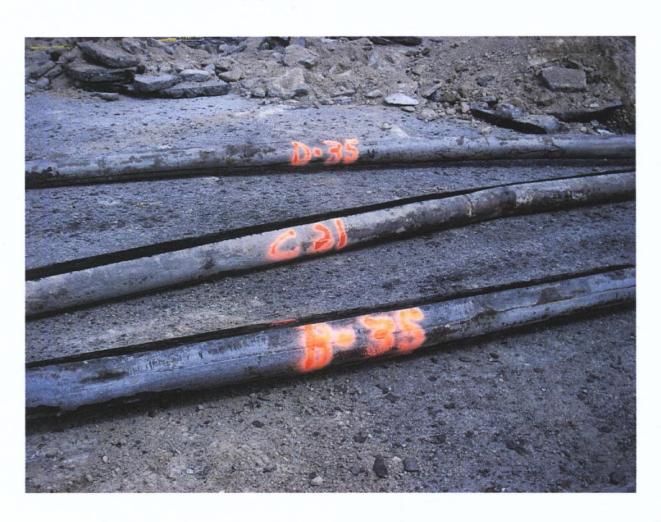
SWP Cleaned Ex-situ from Area Inlet 2 to Area Inlet 4
Sections B, C, D and E
Bottom of pipe (corroded out) facing up

- As described during the meeting on June 10, 2015, initial attempts to clean the 8-inch steel SWP segment from AI #4 to AI #2 were only marginally successful due to poor water return. A fiber-optic camera inspection revealed that the bottom of this 8-inch line was badly corroded. Therefore, the only practicable method to clean that segment of the pipe was to excavate that SWP segment. On 5/12/2015, the 8-inch line from AI #4 to AI #2 was excavated, cleaned ex-situ, videoed to confirm the pipe had been cleaned, and placed back in its original alignment. The excavation area then was backfilled.

As described above, the 8-inch line from AI #4 to AI #2 was excavated, cleaned ex-situ, and photographed and videoed to confirm the pipe had been cleaned. The photographs and video (on CD) are contained in Attachment 3 to this report. Video 5 shows that each segment (A through E) of the 8-inch steel pipe from AI #4 to AI #2 was clean and free of visible sediment prior to placing the pipe back in its original alignment and backfilling the excavation. The video shows the cleaned interior of each section of the removed pipe as follows: Section A was 28 feet in length, B was 35 feet, C was 21 feet, D was 35 feet and E was 50 feet. The photographs provide a good view of the pipe sections and close-up views of cleaned pipe surfaces.

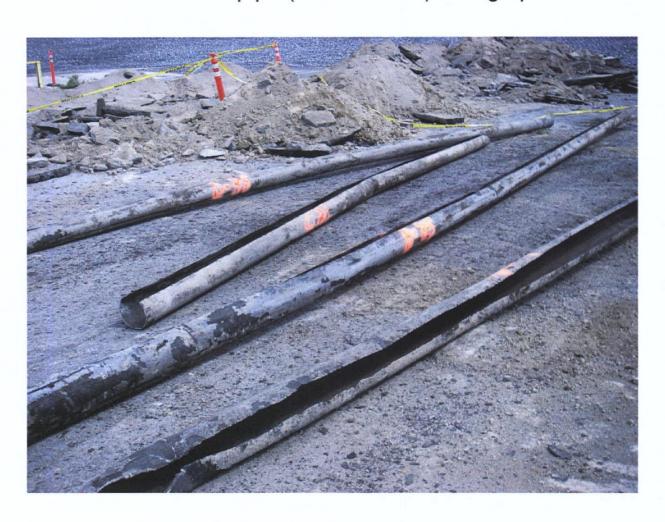
SWP Cleaned Ex-situ from Area Inlet 2 to Area Inlet 4
Close-up view of cleaned segment of pipe (typical of Segments A through E)
